# GE-Pittsfield/Housatonic River Silver Lake Area 2025 Cap System Maintenance

**July 22, 2025**

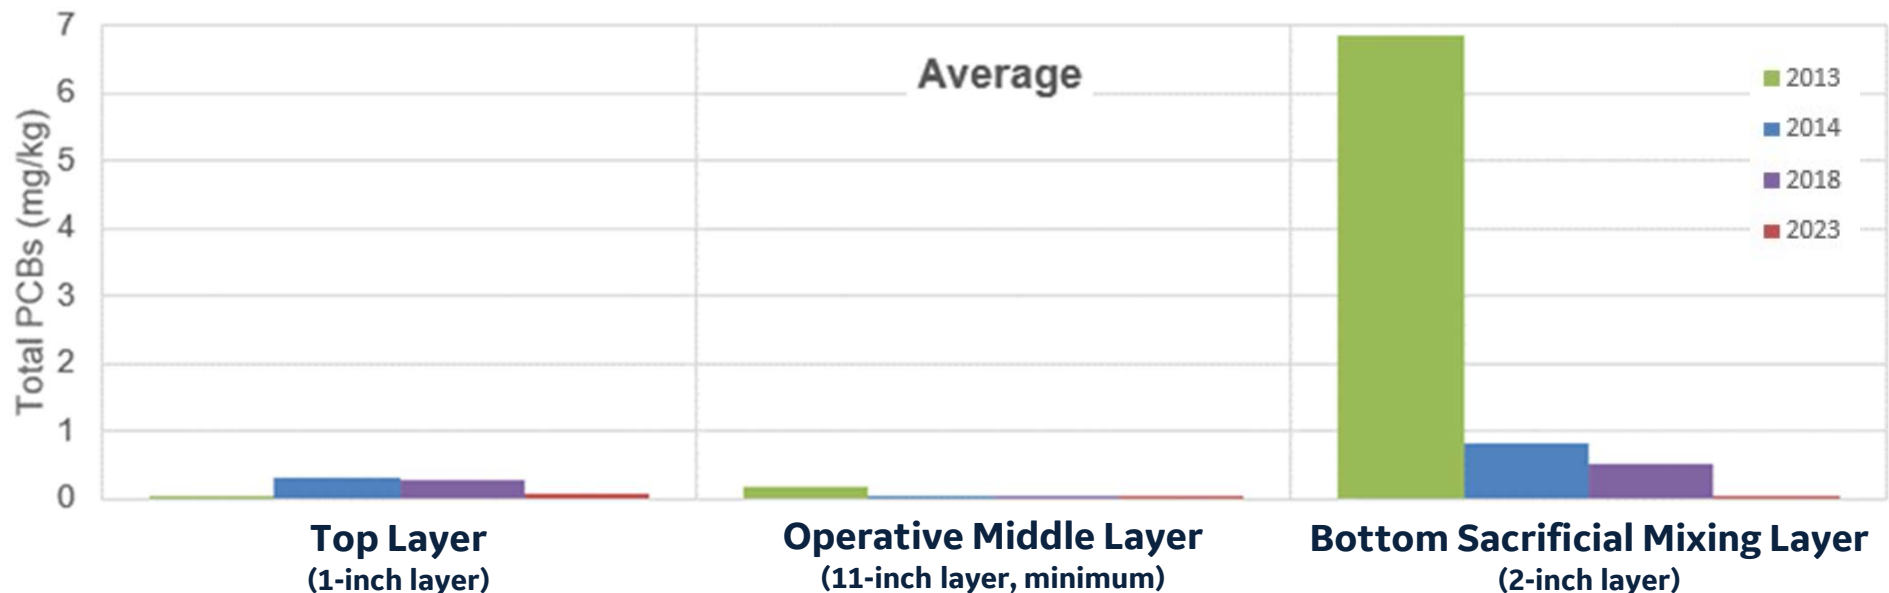
- PCB concentrations are observed to decrease, on average, since construction was completed and are generally not detected in the operative middle layer.
- The isolation layer is performing as designed and expected, effectively limiting migration of PCBs from the underlying sediments through the cap and into the surface water of the lake.

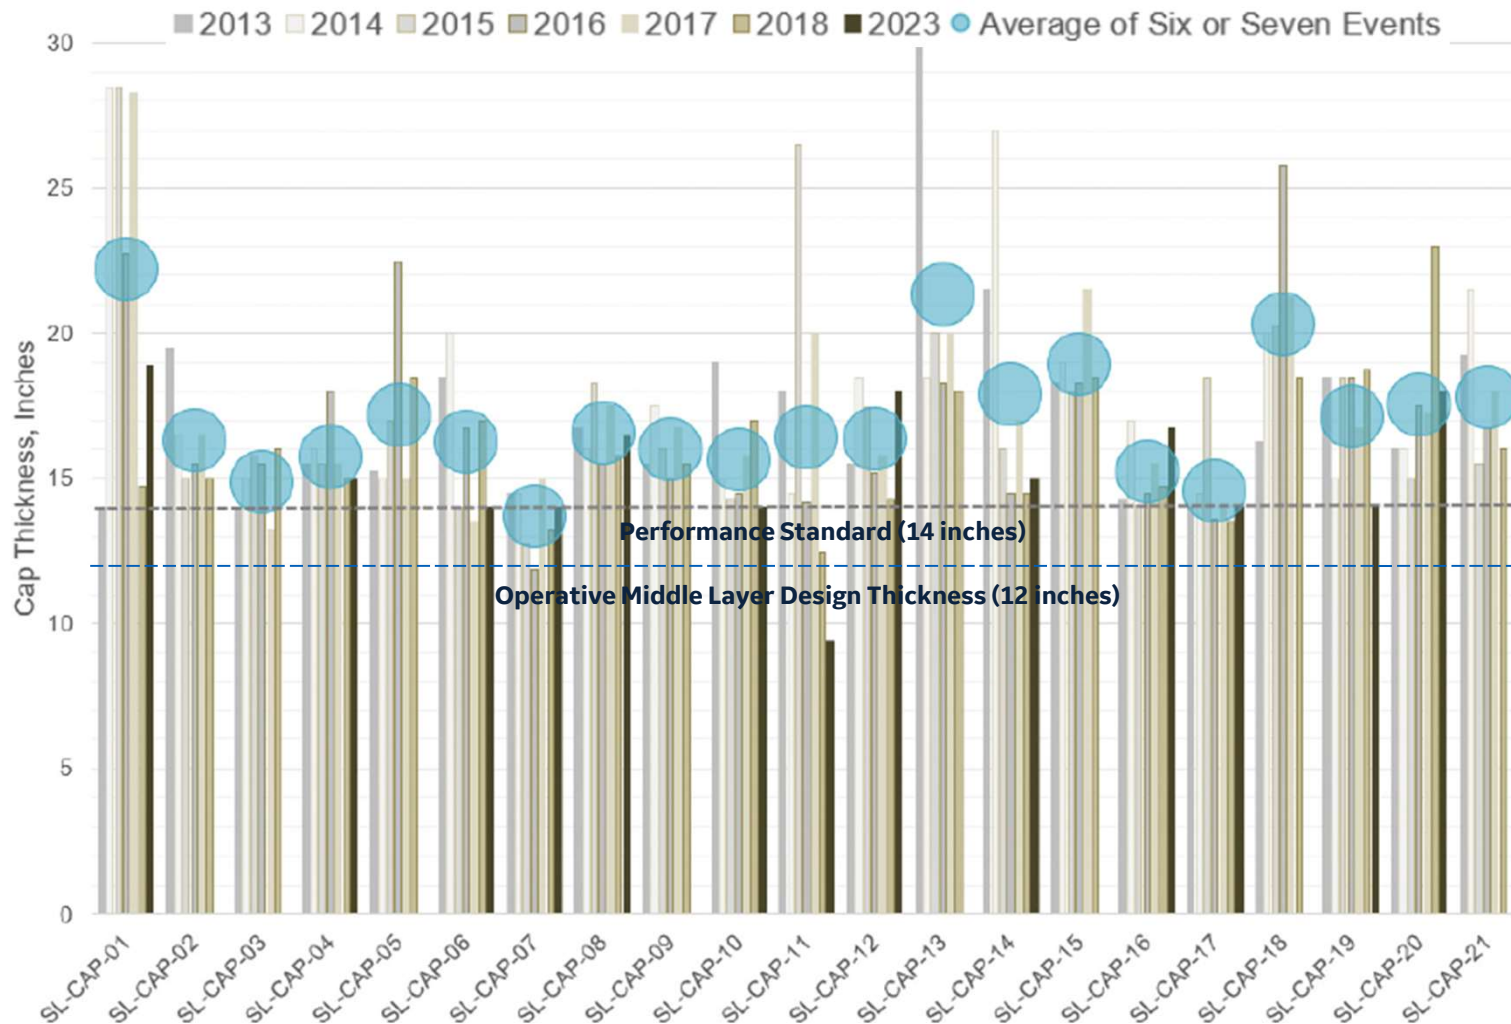
# Post-Construction Monitoring Results for Cap Thickness

- Design standards for the cap thickness have generally been maintained, with the average thickness at each location exceeding/meeting the 14-inch Performance Standard.
- Averages at all locations exceed the 12-inch design thickness for the operative middle layer of the cap, which includes the 6-inch bioturbation layer and 6-inch isolation layer.

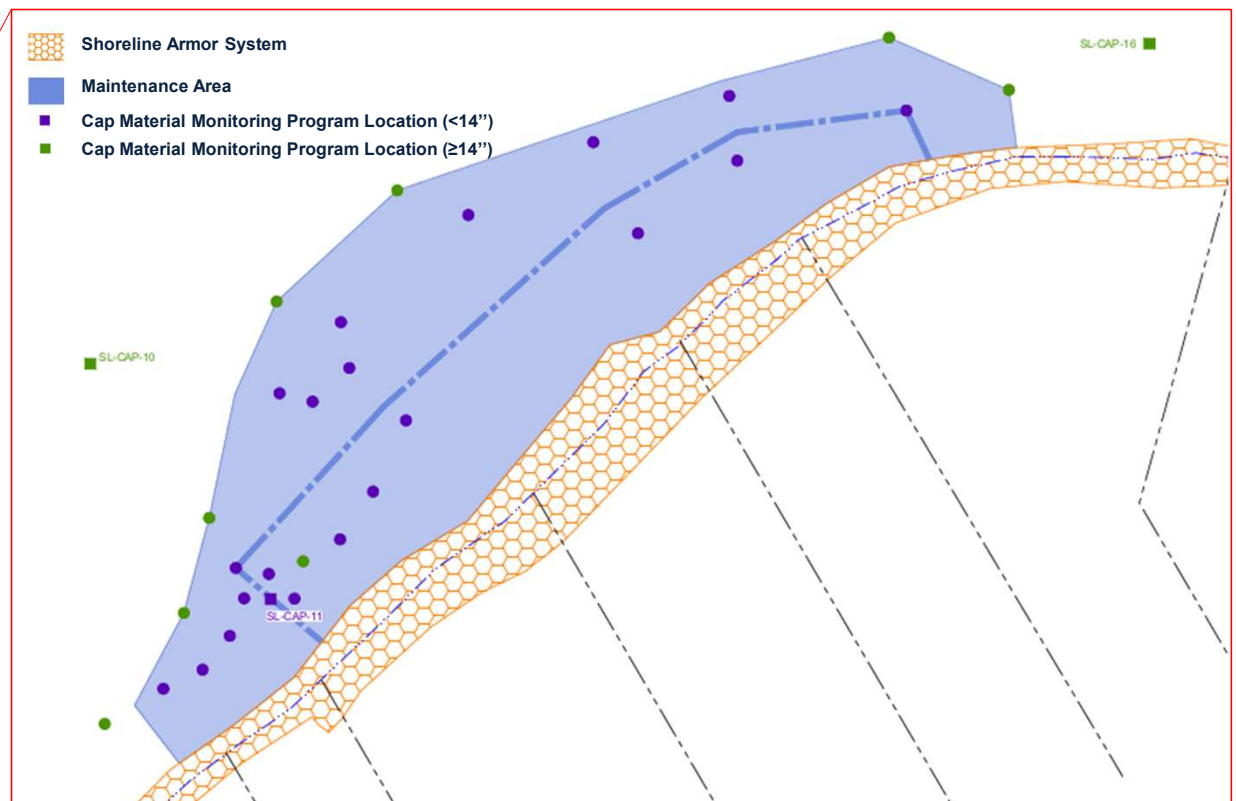
- The cap monitoring program demonstrated that the cap has remained stable over the 10 years since remediation.
- Cap monitoring in 2023 was performed at 13 locations. The results showed:
  - At 12 locations, the cap met the required thickness, with additional sediment deposition observed at many locations on top of the cap.
  - At one location in the southern area of the Lake along East Street (SL-CAP-11), it appeared that the cap thickness was less than the required 14 inches.
- Based on the thickness results observed at SL-CAP-11, additional cores were collected around that location in 2024 to delineate the area in which the cap thickness was observed to be less than 14 inches.

- Based on the 2023-2024 monitoring results, GE has identified an area of approximately 0.76 acres (2.9% of original placement area) over which it plans to add an additional 6 to 9 inches of cap material to re-establish the design cap thickness
